HUMAN FACTORS AND SAFETY EVALUATION OF THE IMPPOVED MESSAGE FACILITY

4. TITLE (and Subtitle)		5. TYPE OF REPORT & PERIOD COVERED		
HUMAN FACTORS AND SAFETY EVALUATION	OF THE	Final Report		
IMPROVED MESSAGE FACILITY		31 May - 19 August 1983

18. SUPPLEMENTARY NOTES				
This report appears as Annex E of Final Test Report for Operational Test II of				
Improved Message Facility, TRADOC TRMS NO 3-OTN-1032, November 1983

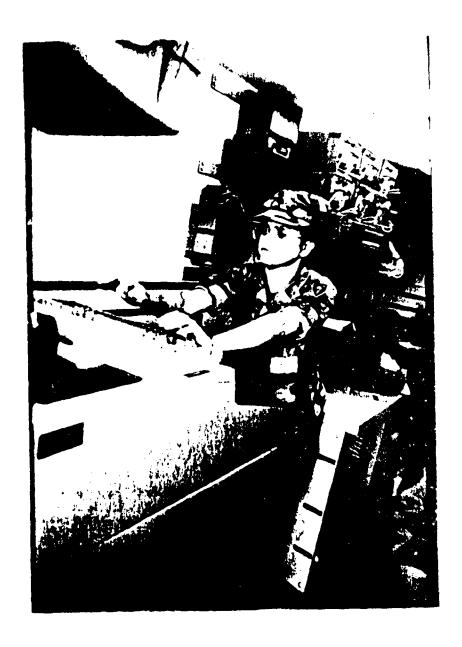
Figure E-1. OCR Operator

- b. A problem associated with the use of the VDU keyboard concerns its location on top of the OCR, making it necessary for an operator to use an extended reach in order to operate the keyboard (Figure 1). This is a position which becomes tiring if maintained for very long, especially for short operators. In the AN/TSC-29, this position of the keyboard in conjunction with the height of the VDU makes for rather awkward operating procedures in that an operator must reach out to use the keyboard and then tilt his head up in order to see what image appears on the VDU. Although the locations of these pieces of equipment are within the height and distance limitations of military standards, operator complaints of the difficulty of working in this position and the resulting neckaches and backaches that sometimes occur, especially with short operators, would dictate that the system be redesigned in order to ameliorate this problem. Lowering the VDU in the AN/TSC-29 and mounting the keyboard on a movable tray that could be pulled closer to the operator are possible solutions to this problem.
